***2017 ASPECT Preliminary Report
Rapids Needs Assessment &
Arkema Plant Response, Crosby, TX***

***September 2, 2017
0700 hrs to 2200 hrs***

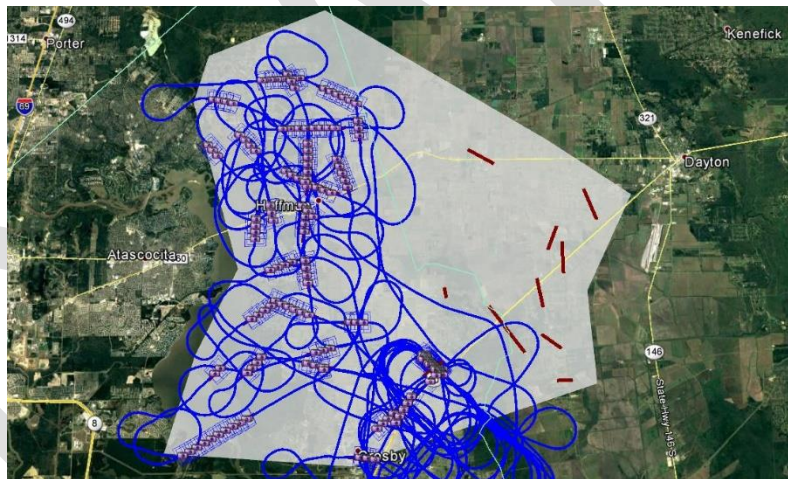
Figure 1: Rapid Needs Assessment flight lines showing aerial photographs. The lines are locations yet to be photographed. The Arkema facility is just northeast of Crosby. Flight occurred on 1 September 2017.

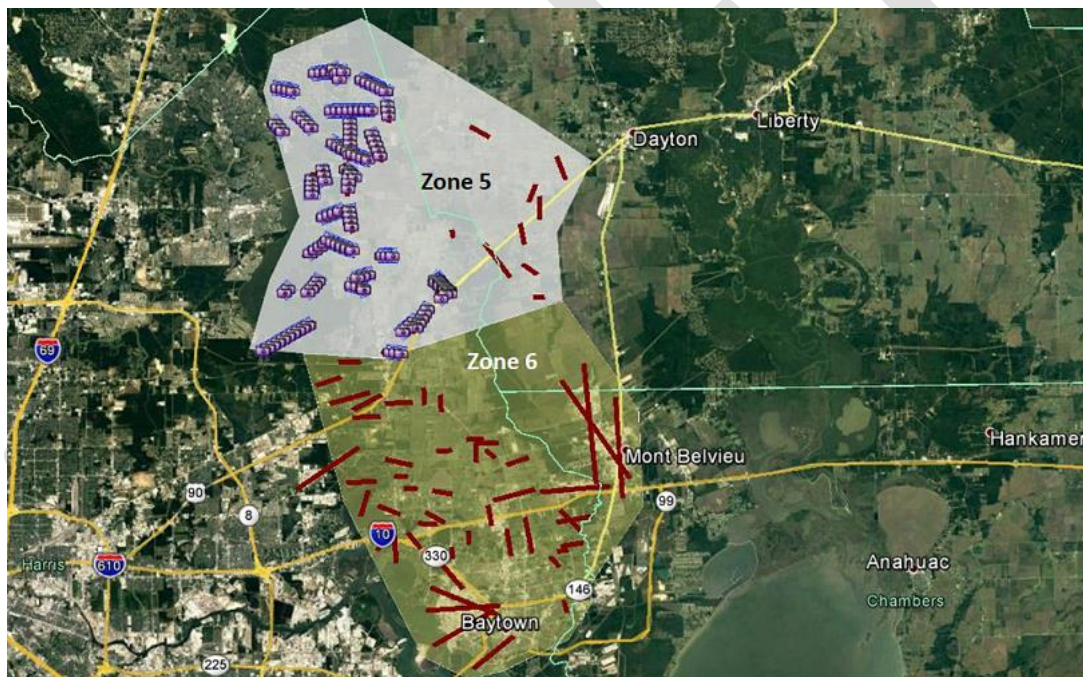
Figure 2: Flight lines in Zones 5 & 6 showing where aerial photography was taken over selected targets on 1 September 2017 for the rapid needs assessment.

On 1 September 2017, ASPECT completed about 50% of Zone 5 (Crosby to Huffman) consisting of approximately 50 targets (36 flight lines). Zone 6 (Crosby down to Baytown) consists of more than 50 targets (49 flight lines).

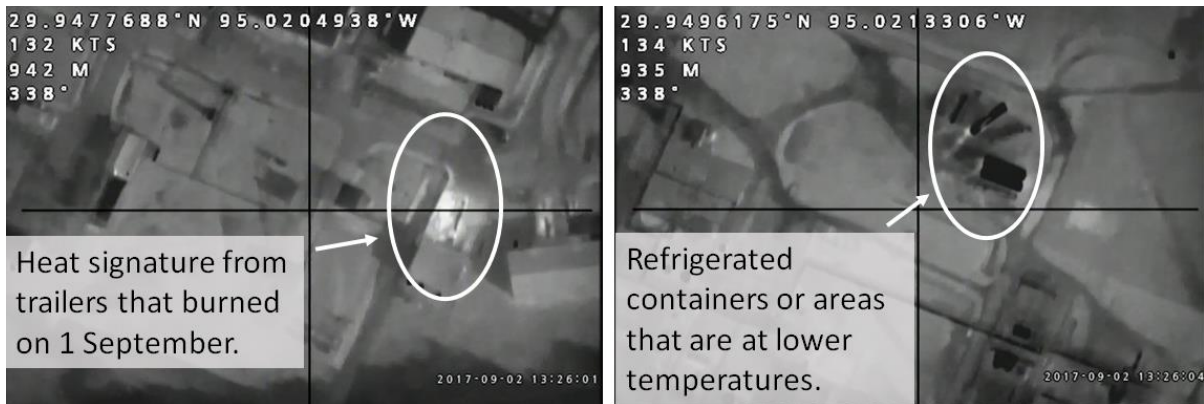
0740 hrs: ASPECT completes a pass over the Arkema facility and reports no significant chemical detections. Figure 3 contains two images taken from the IR video showing a heat signature from the remnants of the trailers that burned on 1 September and the remaining refrigerated trailers.

Figure 3: Infrared images taken from the video (0813 hrs CST) showing the heat signature from the trailers that burned on 1 September (left) and the refrigerated trailers (right).

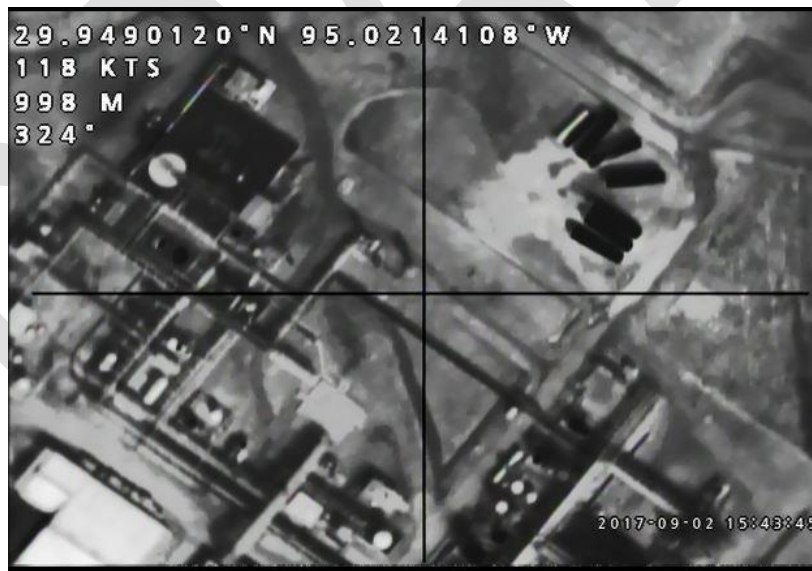
0820 hrs: ASPECT completes a pass over the Arkema facility and reports no significant chemical detections. Figure 4 is an image taken from the IR video showing the remaining refrigerated trailers.

Figure 4: Infrared image taken from the IR video over the six remaining refrigerated trailers.

The image in Figure 4 shows that the trailers appear to be cooler than the surrounding environment at this time suggesting that the ground may be solar heating and increasing the contrast between the trailers and ground.

1145 hrs: ASPECT completes a pass over the Arkema facility and reports no significant chemical detections. IR video continues to show similar images as shown in Figure 4.

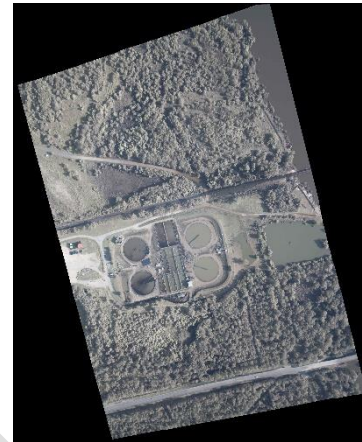
Figure 5: Example of a geo-corrected aerial photo over a water treatment facility. These are part of the rapid needs assessment mission.

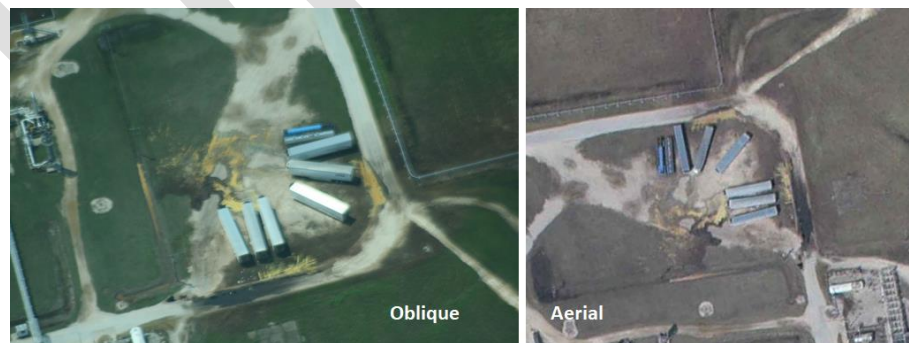
1400 hrs: Robert Bernier, R6 OSC, contacted ASPECT ground control and stated that the Sheriff overflight reported that yellow material was seeping from the six trailers on the ground (see Figure 6). He requested high resolution photos. ASPECT was redirect from the RNA mission to support this request.

Figure 6: Oblique (left) and Aerial (right) photos pulled from the aircraft and shared with the R6 EOC. The oblique image is slightly distorted due to the aircraft windshield. Oblique photos are not typically pulled from the aircraft because the camera is not connected to the aircraft computer system. The crew was able to download this image to the computer so the reach back team could access it via satellite.

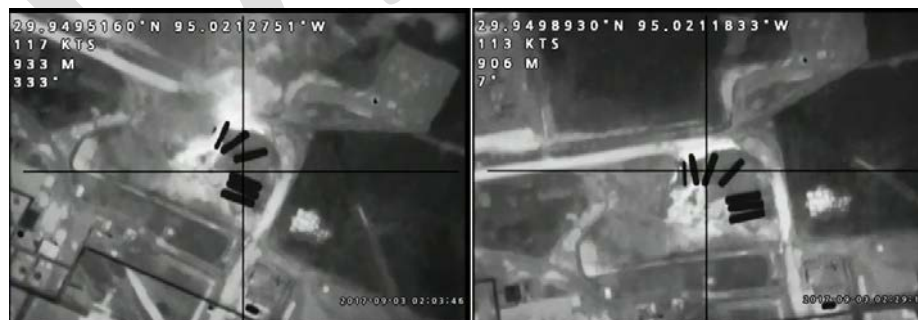
2100 hrs: The manual ignition of the trailers was cancelled. Locals report that one of the trailers is leaking on its own. ASPECT confirmed smoke and made a chemical sweep directly over the trailers. Many chemical detections were made consistent with light hydrocarbons (e.g., 1,3-butadiene) caused by the heated constituents emitted from the trailers. These hydrocarbons were all measured slightly above the limit of detection (about 5 ppm). Other downwind passes (50 m to 100 m) did not show chemical detections above the detection limits. Figure 7 shows two infrared images from independent passes 30 minutes apart.

Figure 7: Infrared images (2100 hrs on left; 2130 hrs on right) taken from IR videos show one of the trailers expelling heat from both ends.
